**Low Moor Road
Sutton-in-Ashfield
Phase 1 Desk Study**

HALLAM LAND MANAGEMENT

Date: 26 January 2017

Job No: P16-549

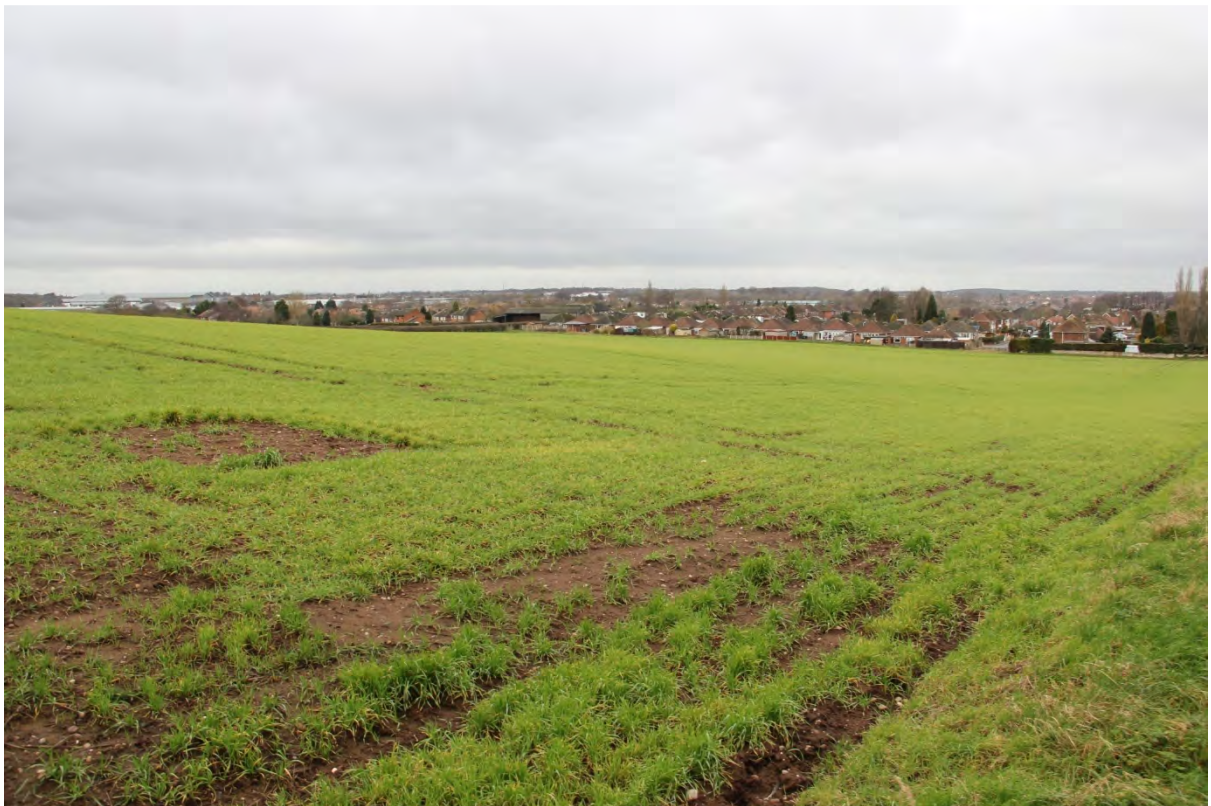
Photo 10 Temporal Parcel lookinh north.

Temporal Parcel – The topography of the Temporal parcel is highly undulating. There is a moderately steep slope from the centre of the Site toward the residential area at the northern boundary at an average gradient of ~1 in 9. Further south there is a large hummock with the land falling towards the east and west. In the southern portion there are more mounds and hummock features with steep sides with gradients of up to 1 in 4. The boundary between the CC and Temporal parcel is marked by a steep bank approximately 5m high (see photographs 10 – 21 in Appendix C).
